## TIMBER MAT - WETLAND CROSSING

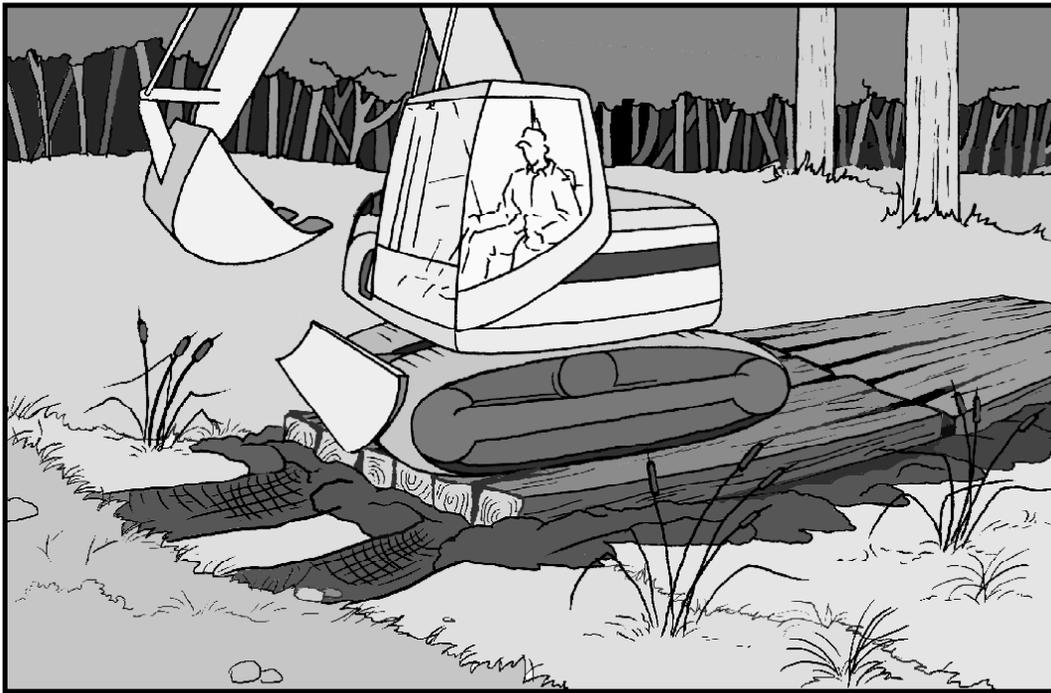
### IMPROPER INSTALLATION

- Long axis of mats is not perpendicular to travel direction
- Mats are working down into wetland causing significant disturbance and picking up mud
- Mats do not extend beyond wetland edge to solid ground

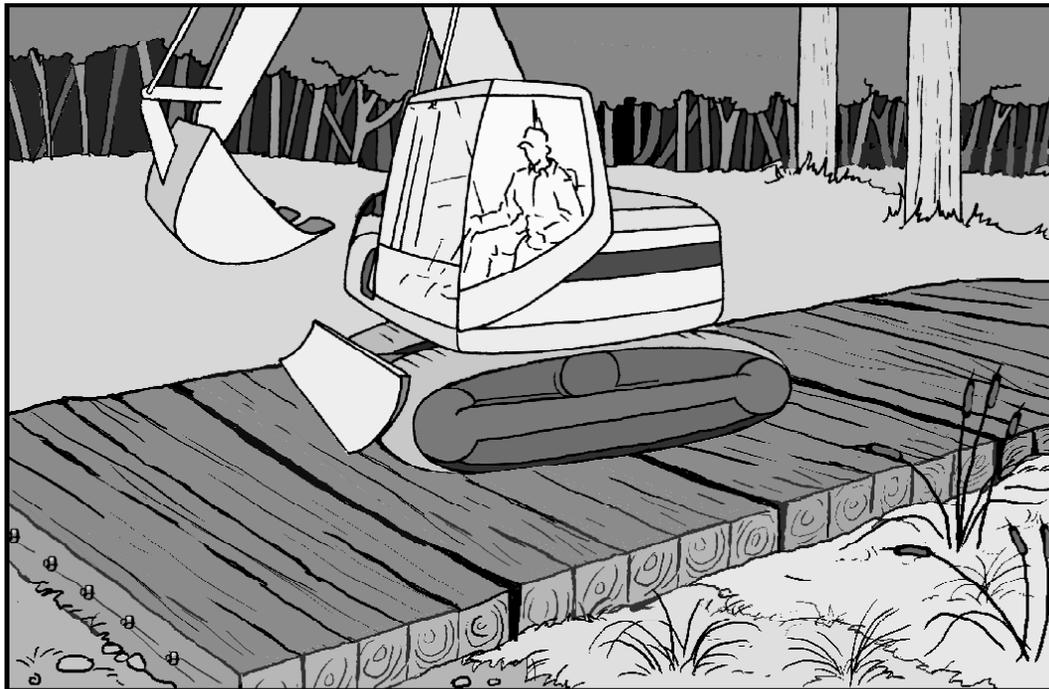
### PROPER INSTALLATION

- Correct orientation relative to travel direction
- Entire wetland is spanned, preventing rutting at ends of crossing
